**Flood Control Project Maintenance  
Levee Inspections**  
**LMA District Cover Sheet**  
**Spring 2019 Levee Inspection Results**

**Sacramento Maintenance Yard Cache Creek**

**Spring 2019 Levee Inspection Results**

Waterway			Bank	Unit Miles
Unit No. 01 North Levee			Left	11.69
	Spring (March - May)	Summer (June - August)	(September - November) Fall	Winter (December - February)
Unit Maintenance Rating (Fall Only)				
Date of Inspection	4/23/2019 - 4/23/2019			
DWR Inspector	Zach Jojola			
Accompanied By

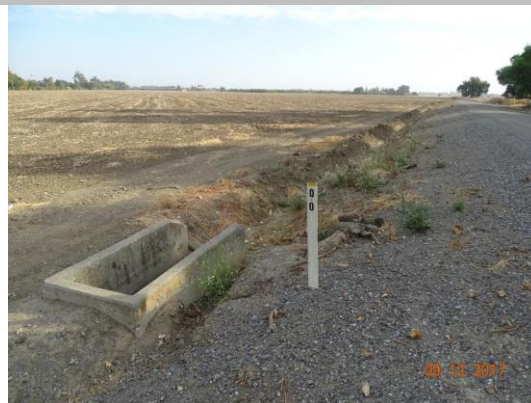
Photo 1 of 2 : SP\_2019\_ST0001\_259\_48\_20190304\_00036.jpg

View of the ditch at the landside levee toe. Fall 2017.

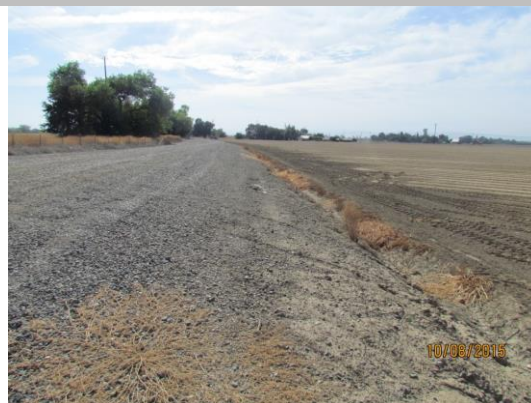
Photo 2 of 2 : SP\_2019\_ST0001\_259\_48\_20190304\_00037.jpg

View of the ditch on the landward side of the levee looking upstream. Fall 2015.

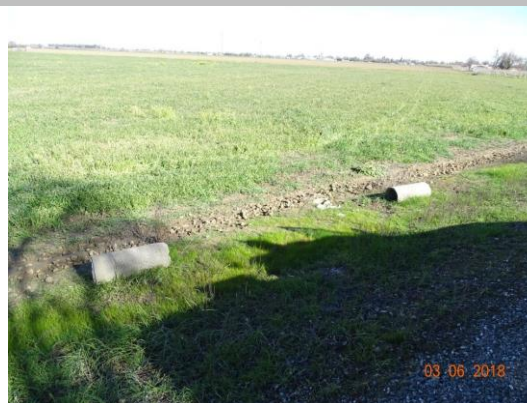
Photo 1 of 1 : SP\_2019\_ST0001\_259\_41\_20190304\_00033.jpg

LM Start	1.04	Rating **	M	Issue No.	41
LM End	1.04	Issue Type +	En	Location *	LS
Category	Earthen Levee			GPS Latitude/Longitude	
				Start	End
Item	Encroachments			38.720327 °	38.720327 °
				-121.813742 °	-121.813742 °
DWR ID	DWR_ST0001_01_s _ 2018_41				
Comment Code					
DE : Debris					
Inspector Comment					
There are broken concrete standpipes on the landside slope.

View of standpipes on landside slope. Spring 2018.

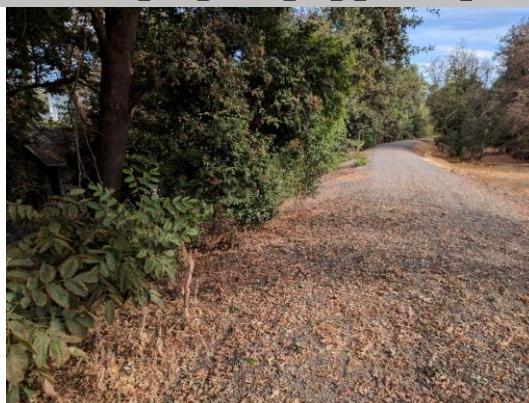
Photo 1 of 3 : SP\_2019\_ST0001\_259\_3\_20190304\_00001.jpg

View of thick vegetation on landside slope. Fall 2017.

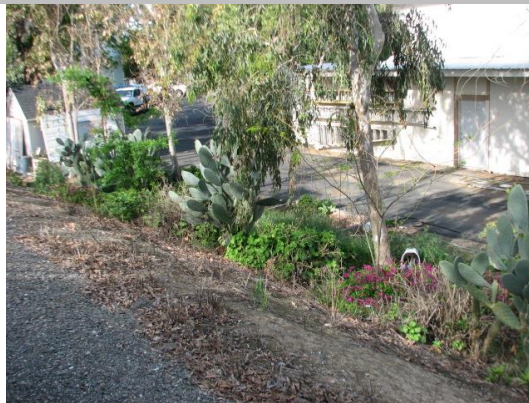
Photo 1 of 1 : SP\_2019\_ST0001\_259\_28\_20190304\_00022.jpg

The property owner has planted cactus along the toe of the levee. Spring 2014

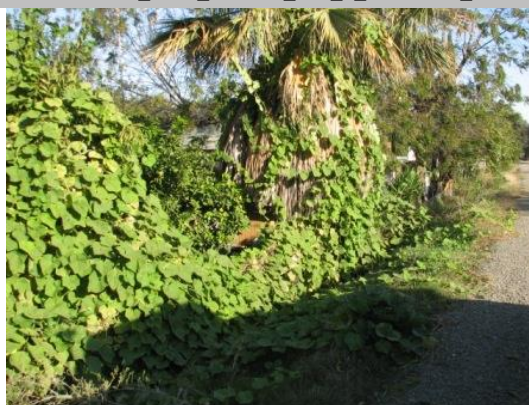
Photo 1 of 2 : SP\_2019\_ST0001\_259\_7\_20190304\_00006.jpg

Wild grape and other plants are obstructing the view for inspection. Fall 2011

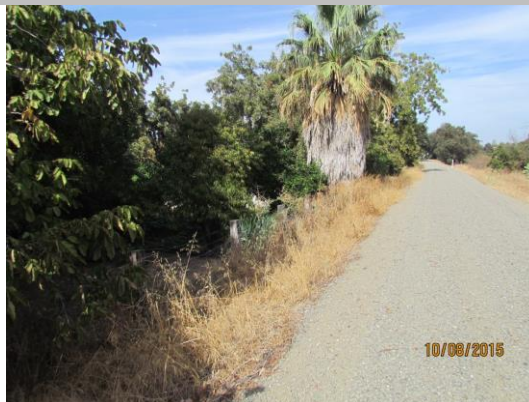
Photo 2 of 2 : SP\_2019\_ST0001\_259\_7\_20190304\_00007.jpg

View of the landscaping on the landward side of the levee looking downstream. Fall 2015.

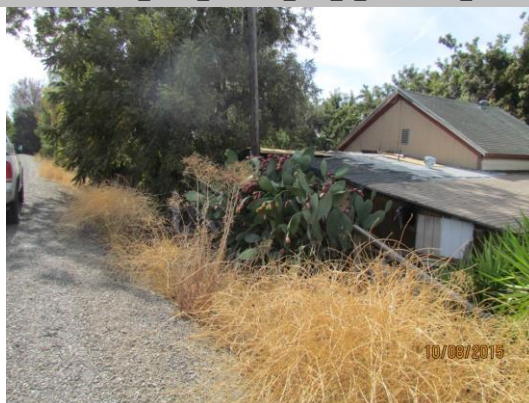
Photo 1 of 1 : SP\_2019\_ST0001\_259\_8\_20190304\_00008.jpg

View of the building on the landward side of the levee looking upstream.  
Cactus planted at the toe obstructs visibility. Fall 2015.

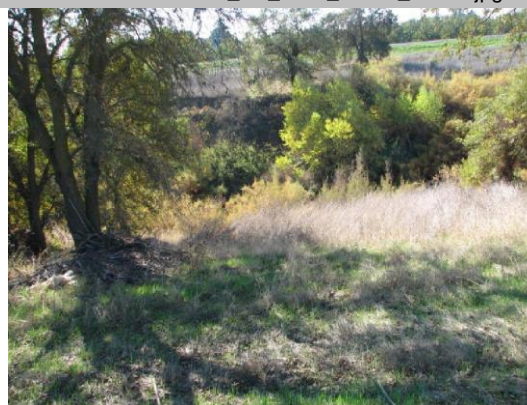
Photo 1 of 3 : UCIP\_SP\_2019\_49099\_60164.jpg

Comment Code					
Inspector Comment					
FS_ID:49099					
DS_ID:16268					
EP_NO: 2415					
Repair Type: Non-Urgent					
Crossing Status: Indicator Found					
UCIP Comments: May need to install gasoline marker on WS slope.					
FIELD_STRUCT_DESC: 20-inch wrapped steel natural gas pipeline through the levee, 4 feet below the crown. Two cutoff walls. Gas line indicator found on the landside (LS) of the levee. (20-inch wrapped steel natural gas pipeline authorized under Permit No. 2415, 1956 - Pacific Gas and Electric Company [PG&E]). [Additional Reference(s): DWR Levee Log, 1993. USACE Sacramento O&M Manual 126, November 1961, (HLM 2.24)].					
FS Date: 6/16/2016 7:00:04 AM

Waterside view: no indicators found

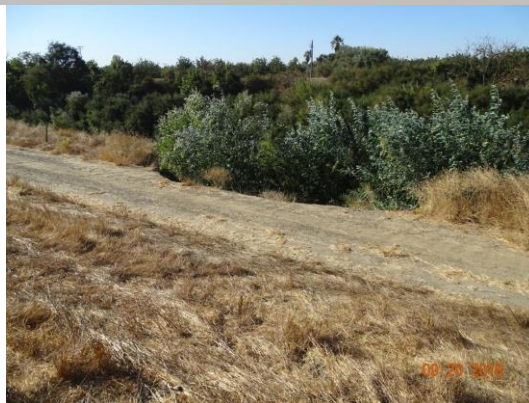
Photo 1 of 3 : SP\_2019\_ST0001\_259\_30\_20190304\_00023.jpg

LM Start	2.57	Rating **	A/W	Issue No.	30
LM End	2.61	Issue Type +	Ma	Location *	WS
Category	Supplemental			GPS Latitude/Longitude	
				Start	End
Item	2017 USACE Erosion Survey, DRAFT			38.732836 °	38.732685 °
				-121.797893 °	-121.797154 °
DWR ID	DWR_ST0001_01_f _ 2018_30				
Comment Code					
Inspector Comment					
2017 Site ID: CHC 2.4 L Status: Critical 2017 Field Notes: No observed change. Site History: Site identified as CRITICAL in 2002. 2006 - Currently constructing a setback levee. New failures present and extensive. Downstream end of the setback levee did not extend far enough. Upstream end was repaired. 2007 - DWR repaired with a setback levee, but the levee did not go far enough downstream. 2012 - New cracks observed. 2013 - Fresh erosion on upper bank.					
DWR Inspector Comment: No observed changes in erosion. Spring 2019.

View of erosion on the waterside toe road. Fall 2018.

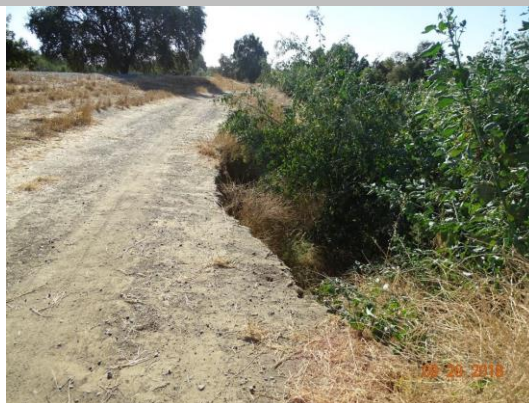
Photo 2 of 3 : SP\_2019\_ST0001\_259\_30\_20190304\_00024.jpg

Additional view of the erosion, facing downstream. Fall 2018.

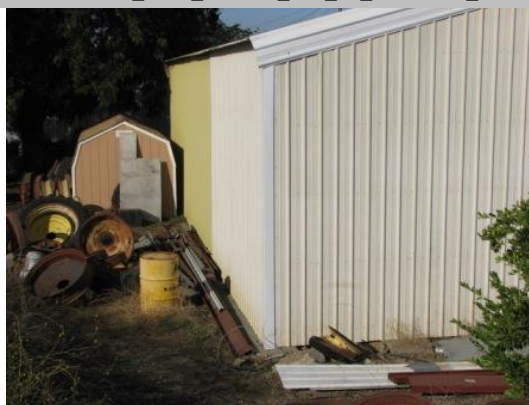
Photo 1 of 2 : SP\_2019\_ST0001\_259\_20\_20190304\_00018.jpg

The corner of the shop is within the easement of the levee. Fall 2011

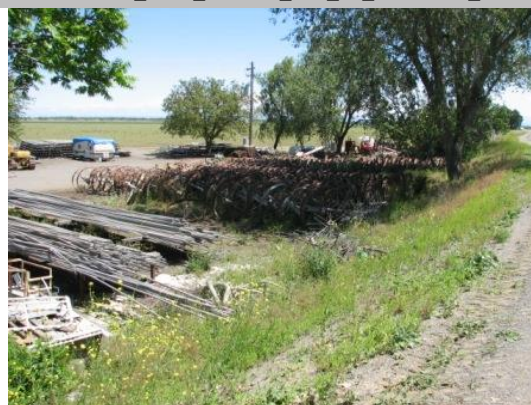
Photo 1 of 2 : SP\_2019\_ST0001\_259\_40\_20190304\_00031.jpg

Irrigation pipe and equipment are within the easement of the levee.

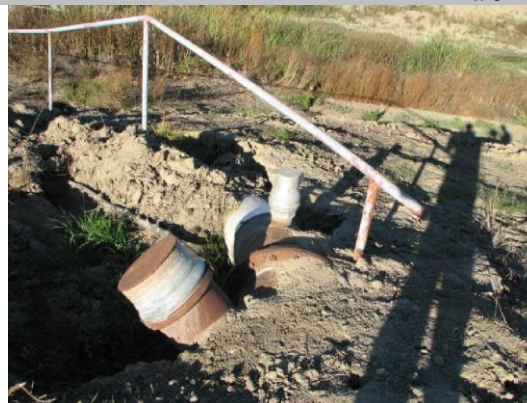
Photo 2 of 3 : UCIP\_SP\_2019\_53215\_60147.jpg

Landside view: pipe daylight on LS levee slope

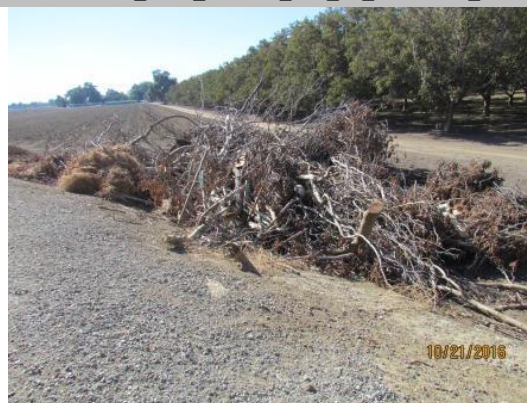
Photo 1 of 1 : SP\_2019\_ST0001\_260\_20\_20190304\_00019.jpg

View of prunings on LS slope of the levee. Fall 2016.

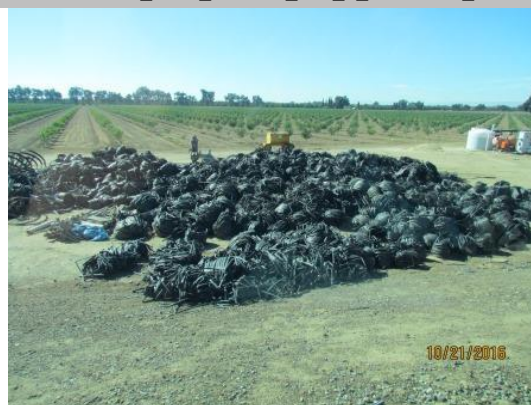
Photo 1 of 2 : SP\_2019\_ST0001\_260\_3\_20190304\_00002.jpg

Additional view of debris at the same site on landward side of the levee.  
Fall 2016.

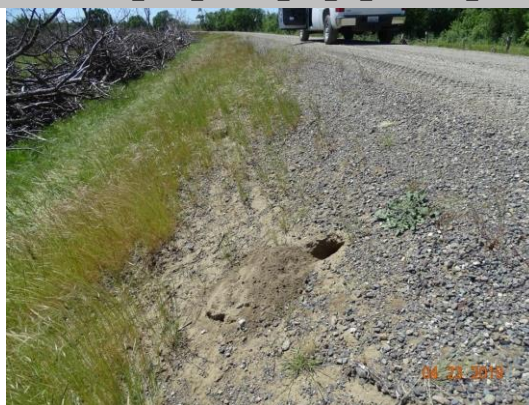
Photo 1 of 1 : SP\_2019\_ST0001\_260\_30\_20190422\_00024.jpg

View of rodent holes on the landside slope. Spring 2019.

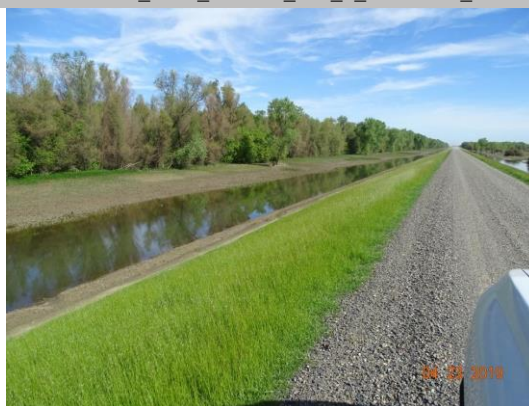
Photo 1 of 1 : SP\_2019\_ST0001\_261\_4\_20190424\_00008.jpg

View of vegetation on the waterside slope. Spring 2019.

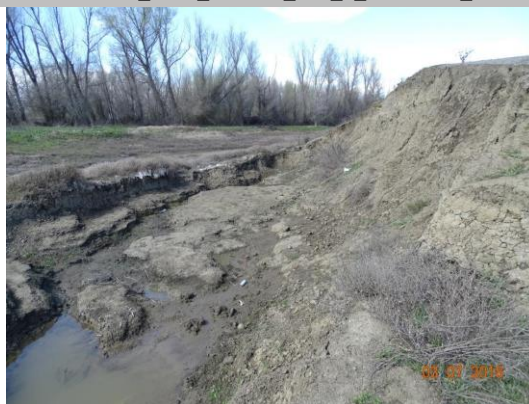
Photo 1 of 4 : SP\_2019\_ST0001\_261\_3\_20190304\_00004.jpg

LM Start	2.26	Rating **	A/W	Issue No.	3
LM End	2.26	Issue Type +	Ma	Location *	WS
Category	Earthen Levee			GPS Latitude/Longitude	
				Start	End
Item	Erosion / Bank Caving			38.695416 °	38.695416 °
				-121.715943 °	-121.715943 °
DWR ID	DWR_ST0001_04_s_2017_3				
Comment Code					
E2 : Schedule repair of erosion site prior to the next inspection.					
Inspector Comment					
Scour on waterside levee slope at end of Unit 04 levee. There is no visible active erosion at this time, however future high water events will likely cause further erosion into the levee prism.

View of scour on waterside levee slope at the end of Unit 4. Spring 2018.
